Project InformationProject Name
Volo ServicesClient's ref :
Volo-01-02-32Contractor's ref :
SampleDate:
19/09/2016

Inspection Report

Section Number : 1	Date : 19/09/2016	Client's Ref : Volo-01-02-32	Weather : No rain or snow	Critical Drain/Sewer:	PLR : MH1 X
Operator : JOHN.B	Vehicle :	Camera :	Preset :	Cleaned : no	Type of Drain : Gravity drain/sewer

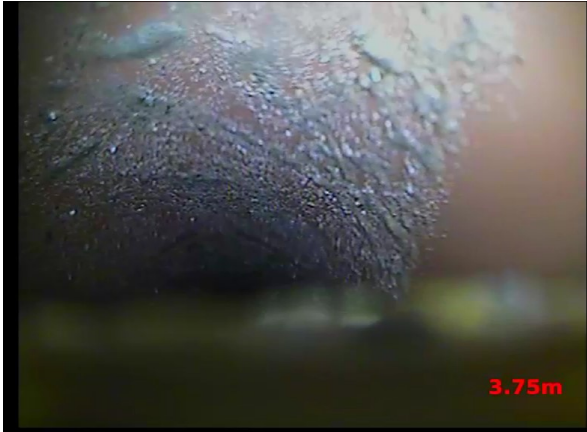
<table><tr> <td style="width: 10%; text-align: center;">0.00</td> <td style="width: 5%; text-align: center;">MH</td> <td style="width: 45%;">Start node type, manhole, reference number: MH1</td> <td style="width: 10%; text-align: center;">00:00:00</td> <td style="width: 5%;"></td> <td style="width: 5%; text-align: center;">0</td> </tr><tr> <td style="text-align: center;">3.63</td> <td style="text-align: center;">WL</td> <td>Water level, 50% of the vertical dimension</td> <td style="text-align: center;">00:00:24</td> <td></td> <td style="text-align: center;">0</td> </tr></table>

, 00:00:24, 3.63m
Water level, 50% of the vertical dimension

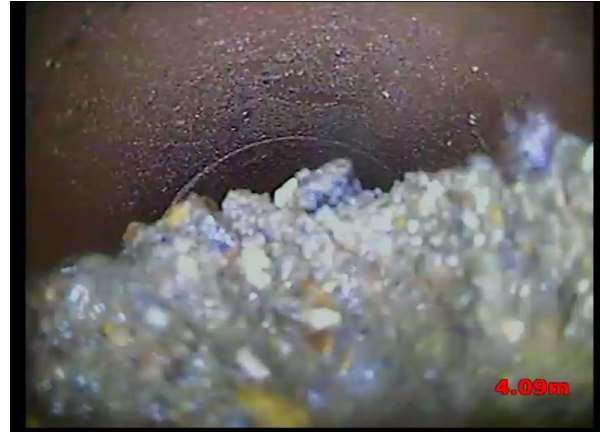
<table><tr> <td style="width: 10%; text-align: center;">0.00</td> <td style="width: 5%; text-align: center;">MH</td> <td style="width: 45%;">Start node type, manhole, reference number: MH1</td> <td style="width: 10%; text-align: center;">00:00:00</td> <td style="width: 5%;"></td> <td style="width: 5%; text-align: center;">0</td> </tr><tr> <td style="text-align: center;">4.09</td> <td style="text-align: center;">DER</td> <td>Settled deposits, coarse, 80% cross-sectional area loss</td> <td style="text-align: center;">00:00:38</td> <td></td> <td style="text-align: center;">5</td> </tr></table>

Structural defects					Constructional features				
Service and maintenance defects					Miscellaneous features				
STR no def	STR peak	STR mean	STR total	STR grade	SER no def	SER peak	SER mean	SER total	SER grade
0	0.0	0.0	0.0	1.0	1	10.0	0.6	10.0	5.0

, 00:00:38, 4.09m
Settled deposits, coarse, 80% cross-sectional area loss

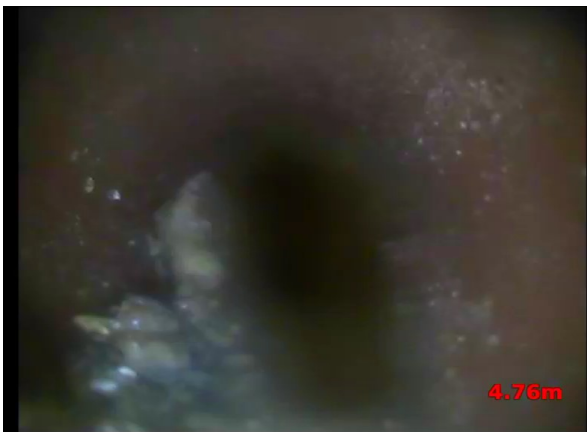
<table><tr> <td style="width: 10%; text-align: center;">0.00</td> <td style="width: 5%; text-align: center;">MH</td> <td style="width: 45%;">Start node type, manhole, reference number: MH1</td> <td style="width: 10%; text-align: center;">00:00:00</td> <td style="width: 5%;"></td> <td style="width: 5%; text-align: center;">0</td> </tr><tr> <td style="text-align: center;">4.79</td> <td style="text-align: center;">SA</td> <td>Survey abandoned: Unable to continue due to build-up of debris.</td> <td style="text-align: center;">00:01:17</td> <td></td> <td style="text-align: center;">0</td> </tr></table>

, 00:01:17, 4.79m
Survey abandoned / Unable to continue due to build-up of debris.

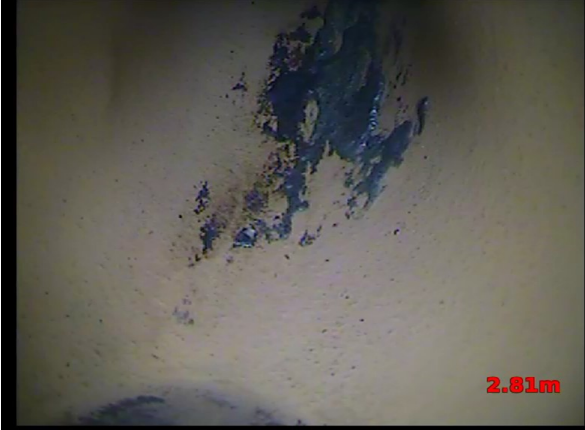
, 00:00:22, 2.81m
Finish node type, major connection without manhole,
reference number: Soil Vent
