Project InformationProject Name
Volo ServicesClient's ref :
Volo-01-02-32Contractor's ref :
SampleDate:
19/09/2016

Inspection Report

Section Number : 1	Date : 19/09/2016	Client's Ref : Volo-01-02-32	Weather : No rain or snow	Critical Drain/Sewer:	PLR : MH1 X
Operator : JOHN.B	Vehicle :	Camera :	Preset :	Cleaned : no	Type of Drain : Gravity drain/sewer

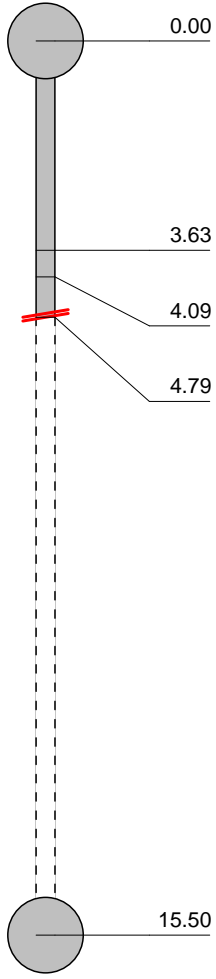
<table><tr> <td style="width: 10%; text-align: center;">0.00</td> <td style="width: 5%; text-align: center;">MH</td> <td style="width: 45%;">Start node type, manhole, reference number: MH1</td> <td style="width: 10%; text-align: center;">00:00:00</td> <td style="width: 5%;"></td> <td style="width: 5%; text-align: center;">0</td> </tr><tr> <td style="text-align: center;">3.63</td> <td style="text-align: center;">WL</td> <td>Water level, 50% of the vertical dimension</td> <td style="text-align: center;">00:00:24</td> <td></td> <td style="text-align: center;">0</td> </tr><tr> <td style="text-align: center;">4.09</td> <td style="text-align: center;">DER</td> <td>Settled deposits, coarse, 80% cross-sectional area loss</td> <td style="text-align: center;">00:00:38</td> <td></td> <td style="text-align: center;">5</td> </tr><tr> <td style="text-align: center;">4.79</td> <td style="text-align: center;">SA</td> <td>Survey abandoned: Unable to continue due to build-up of debris.</td> <td style="text-align: center;">00:01:17</td> <td></td> <td style="text-align: center;">0</td> </tr></table>
